# Manhole Inspection Summary

Manhole # S23II\_010MH

Insp Date: **9/28/07 1:05 PM**

**Location** Address: **625 BAKER ST**

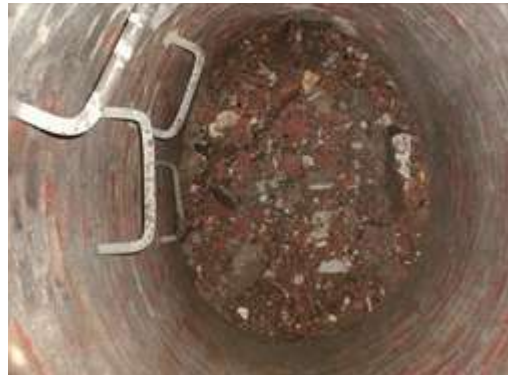
Top View

Channel debris.

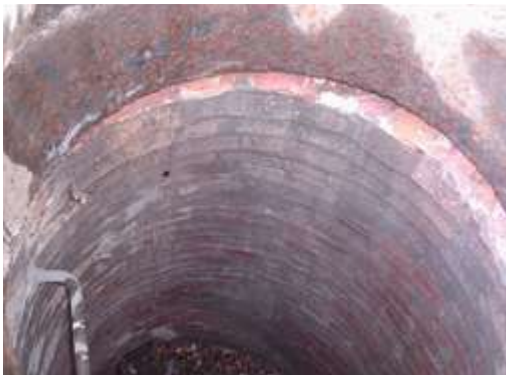
Defect

Adjustment deterioration and infiltration.  
Barrel infiltration - other side.

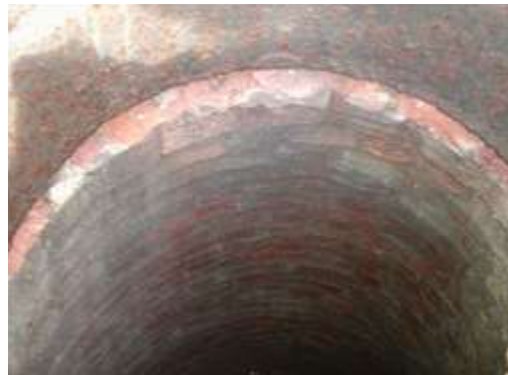
Defect

Adjustment deterioration and infiltration.  
Barrel infiltration.

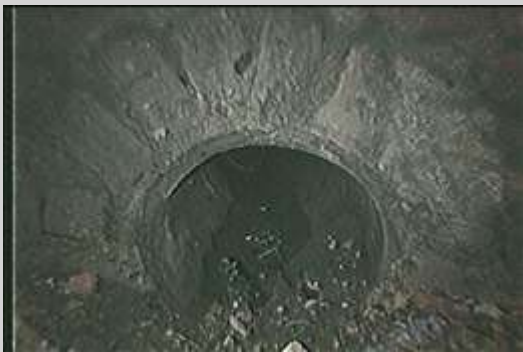
8 in. Circular Gravity Sewer  
Pipe Out @ 12 O'Clock

Deposits: ☐ None ☒ **Mud** ☐ Sludge ☒ **Debris** ☐ Grease

Silt Depth: **1** (in.) Deposits Extent: **Light**

Infiltration: **Evidence** Pipe Seal Cond: **Unknown**
